Transportation Safety Board
of Canada

MARINE INVESTIGATION REPORT
M00H0008

FOUNDERING

FISHING VESSEL AVATAQ
WESTERN SHORE OF HUDSON BAY
25 AUGUST 2000

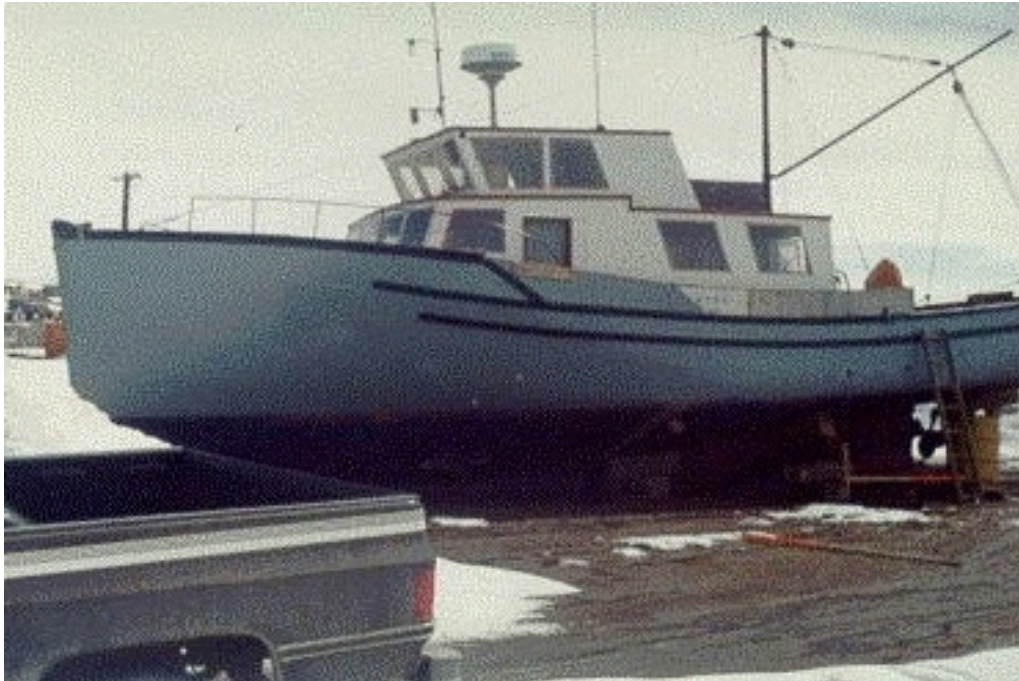
Figure 1. *Avataq* circa 1990

The *Avataq* was a small fishing vessel of open construction, with forward accommodation and wheelhouse (Figure 1). Two flush, non-watertight hatches were inset into the afterwelldeck. The hull was constructed of moulded glass-reinforced plastic (GRP) and stiffened by 19-mm plywood bulkheads spaced 82 cm apart. Some of these bulkheads had been removed to accommodate cargo below decks. Deck beams consisted of 10-cm-by-10-cm spruce overlaid with a 2.5-cm plywood deck. The afterdeck was drained by two threaded 7.6-cm scuppers on each side. An aluminum skiff was carried secured to the foredeck.

Little is known of the stability characteristics of the *Avataq* when heavily loaded, with little residual freeboard. The design to which the *Avataq* was built is such that the space below deck was subdivided into a number of small compartments by transverse bulkheads. As a result, the *Avataq* carried most of its bulky, heavy cargo lashed on the deck. As demonstrated on a previous voyage during which the vessel nearly capsized, when loaded with 15 823 kg of cargo in this manner, the vessel's centre of gravity would have risen to a point where the vessel had little margin of stability. When fully loaded, the vessel's freeboard was 40 cm. The scuppers were therefore below the waterline, and barrel plugs had been screwed into them to prevent water from flooding the afterdeck.

Although this arrangement prevented water from backflooding the afterdeck, it also caused the vessel to retain any water shipped on deck. When the *Avataq* encountered heavy seas south of Arviat, it began to ship water on the afterdeck. Without watertight hatches, some of the shipped water would have downflooded into the hull; however, most would have been retained on the afterdeck. Whenever water is shipped and retained on deck, a free surface effect effectively reduces stability by causing a rise in the virtual centre of gravity. The free surface effect of the shipped water retained on the afterdeck probably reduced the vessel's already marginal transverse stability characteristics, causing the *Avataq* to heel, downflood, and sink.
